Institute of Nuclear Power Operations

The Nuclear Accident at the Fukushima Daiichi Nuclear Power Station

Steve Meng
Manager, Emergency Preparedness

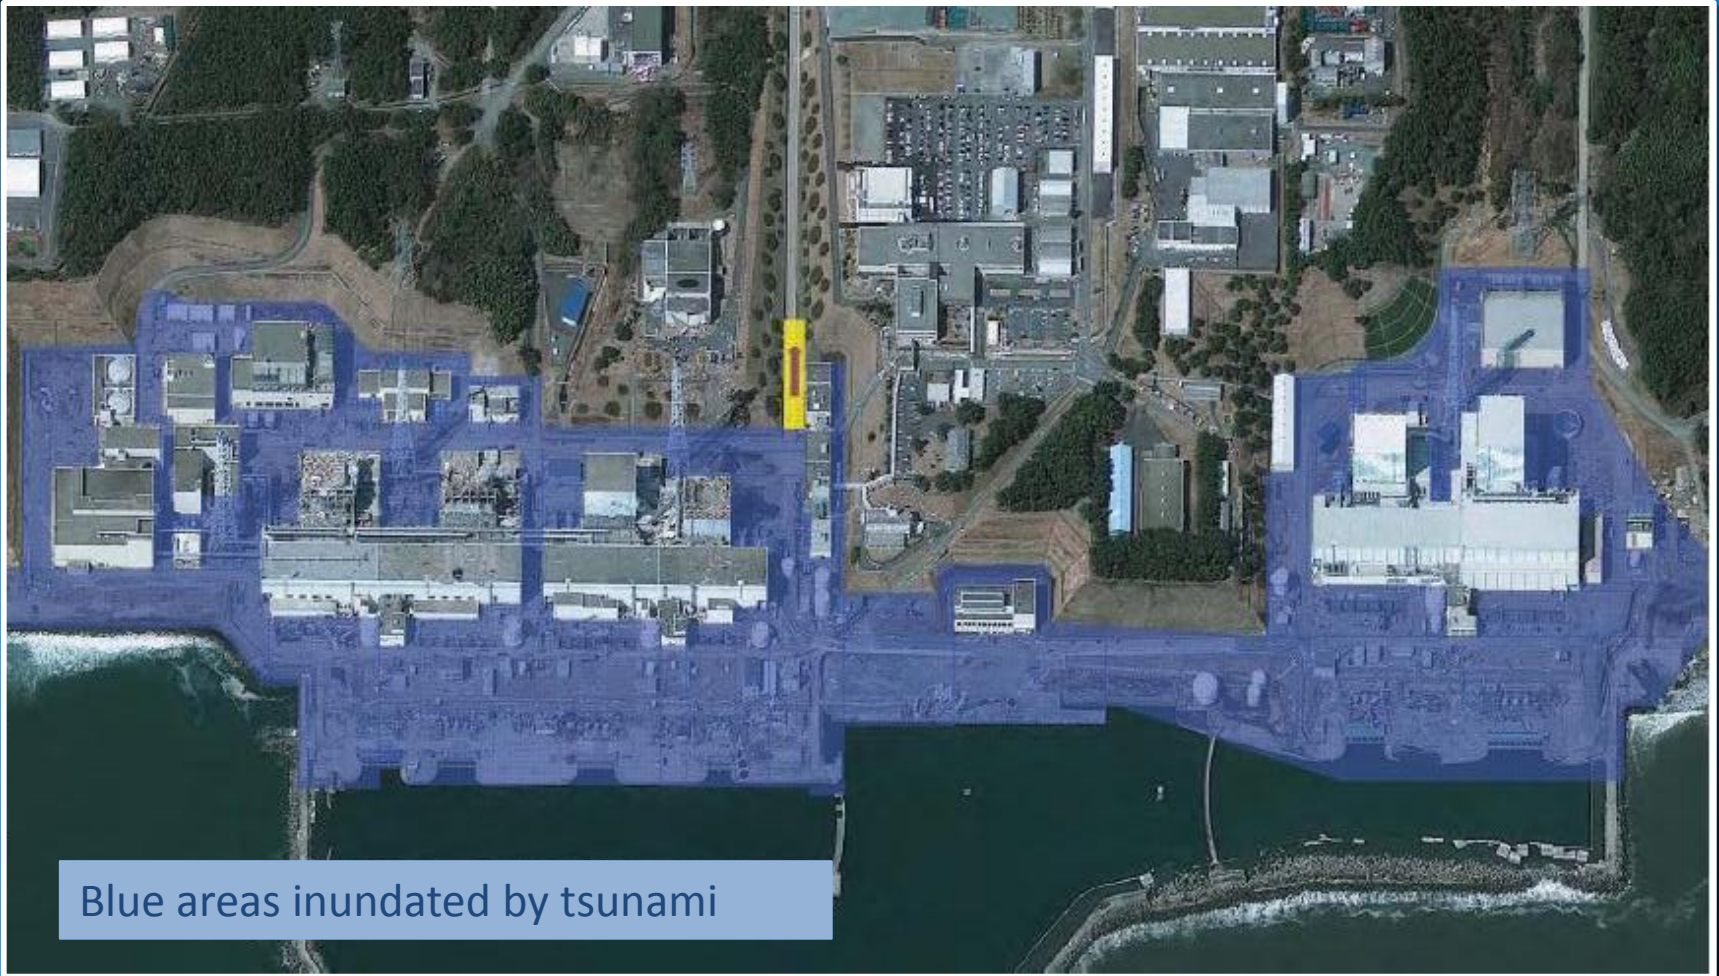
Fukushima Daiichi Inundation

Blue areas inundated by tsunami

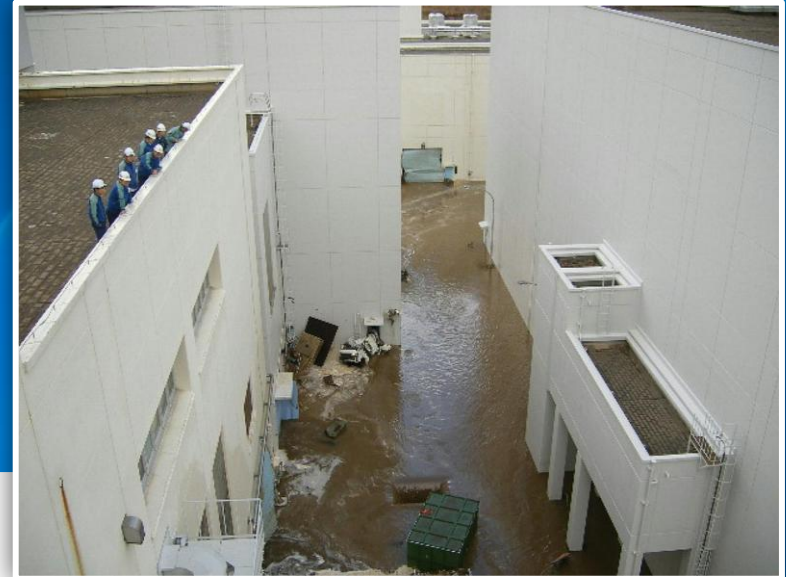
Red line indicates
inundation level

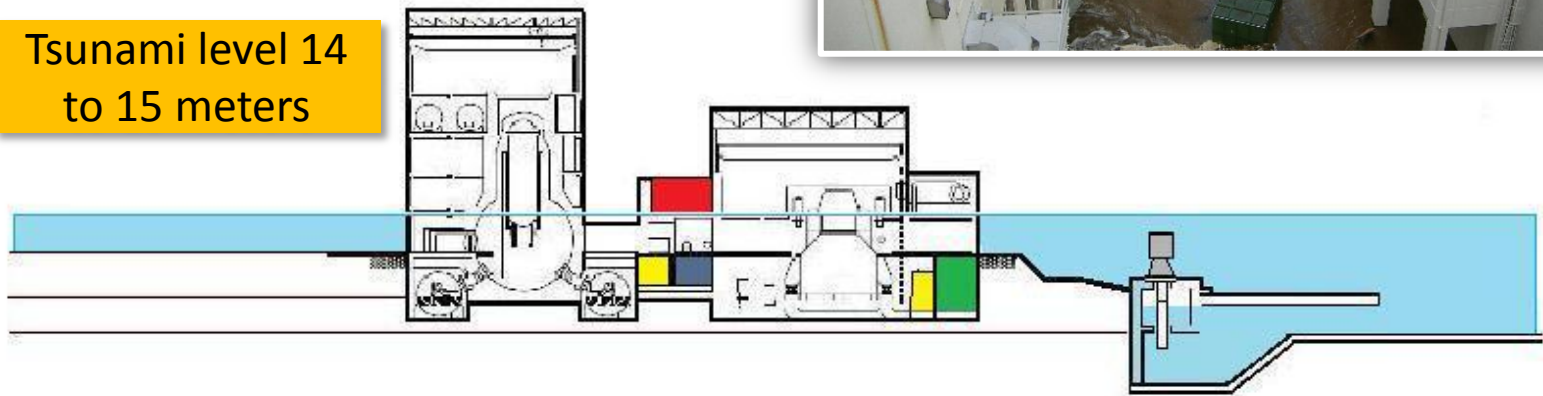
Tsunami level 14
to 15 meters

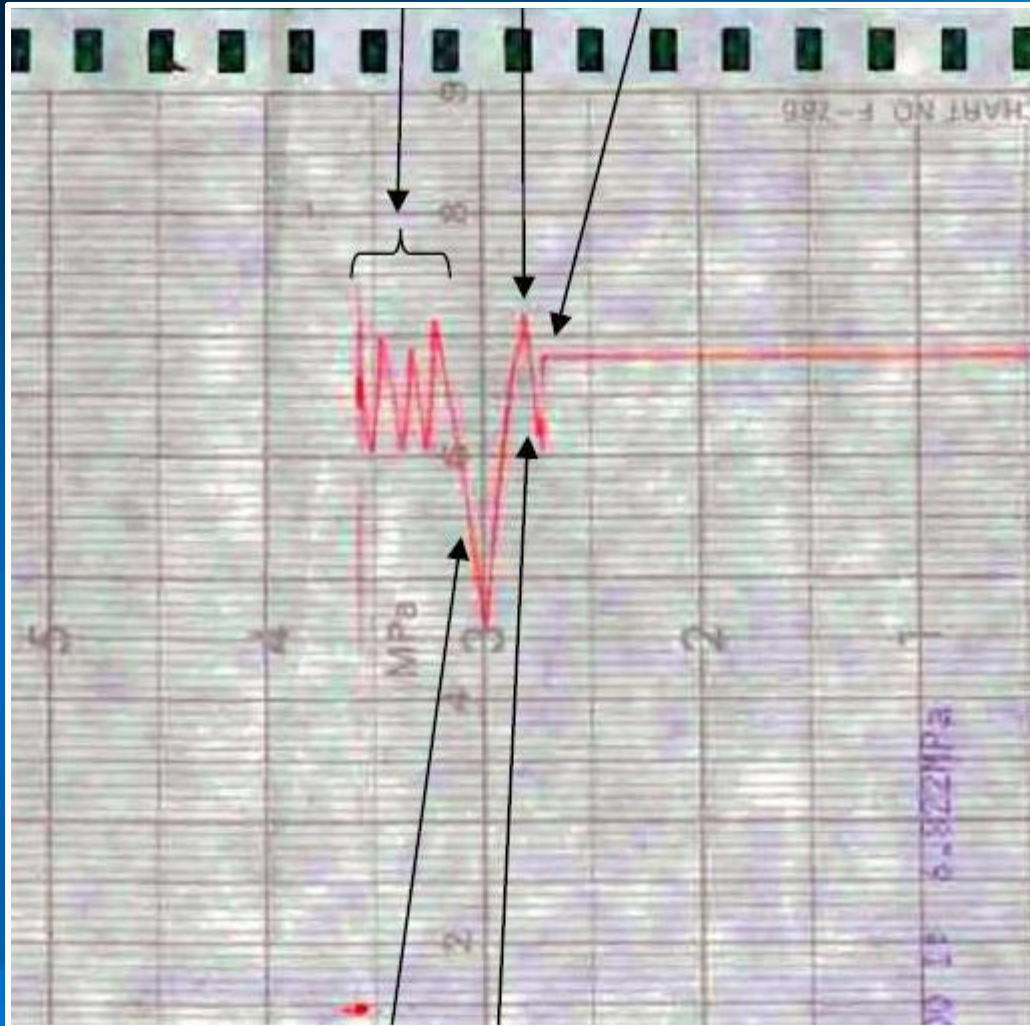
- Unit 1 MCR chart recorder for reactor pressure
- Changes in pressure demonstrate use of IC to control reactor pressure.

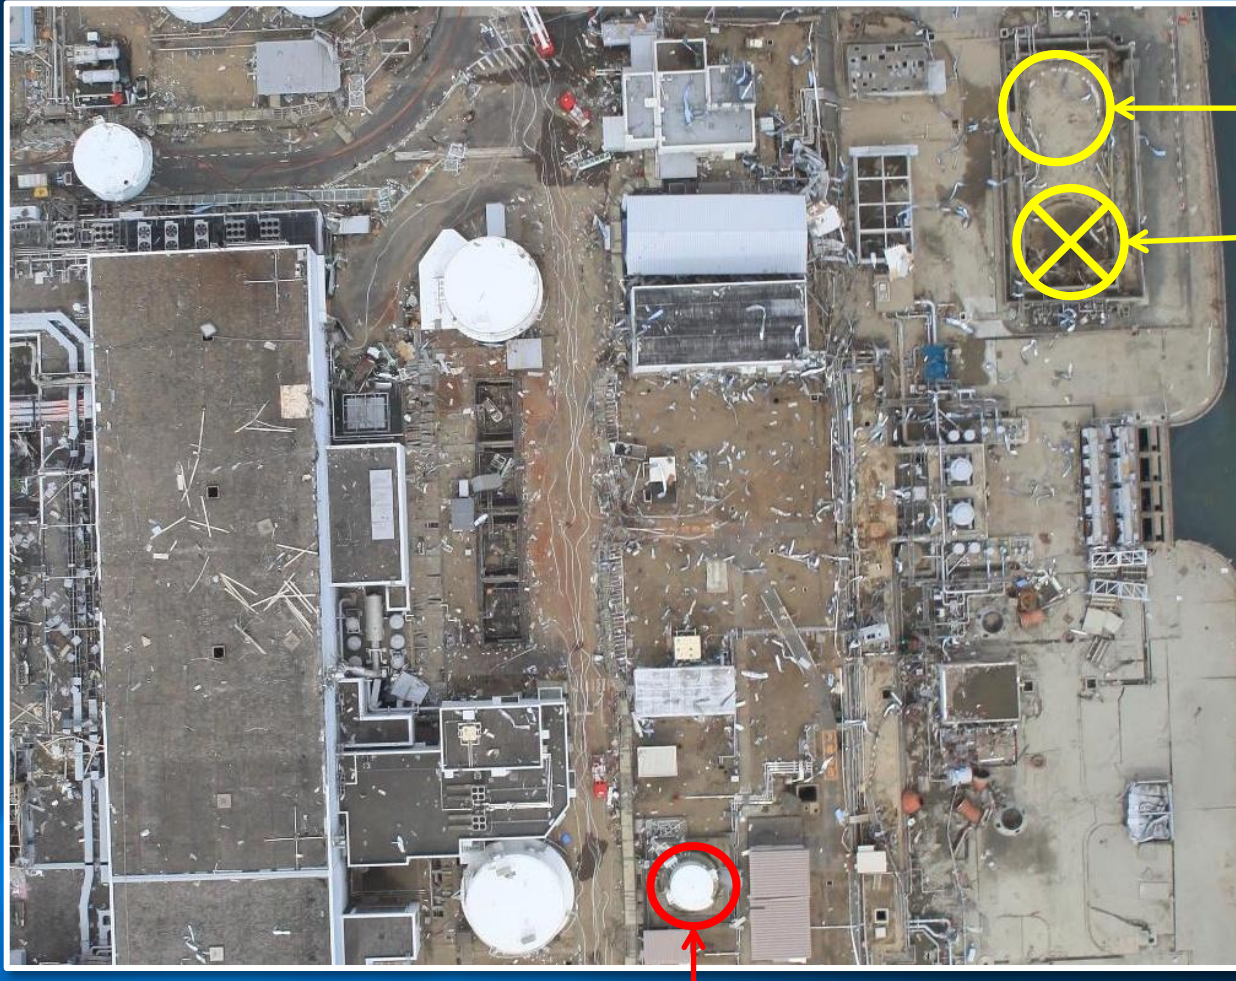
Unit 1-2 EDG Fuel Oil Storage Tank

EDG fuel oil storage tank remains intact

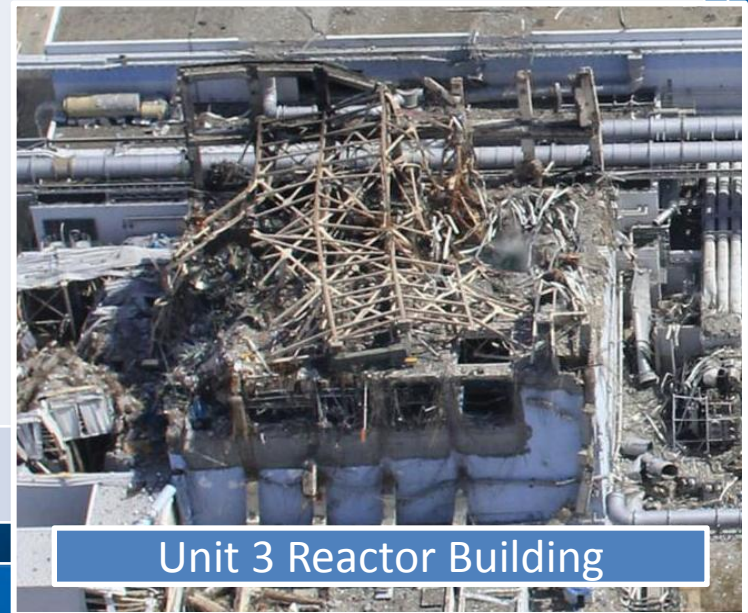
Unit 3 Reactor Building

Time	Unit 1	Unit 2	Unit 3
1101		<ul style="list-style-type: none">• Blowout panel in reactor building dislodged by explosion in Unit 3• Secondary containment lost	<ul style="list-style-type: none">• Hydrogen explosion• Secondary containment destroyed• Eleven workers injured• Debris damages portable generators and temporary power cables
1325		<ul style="list-style-type: none">• RCIC trips resulting in a loss of injection into the reactor• At the time of the trip, indicated reactor water level was approximately 95 inches (2400 mm) above the top of active fuel and drywell pressure was 67 psi (465 kPa).	
1717		<ul style="list-style-type: none">• Indicated RPV level below TAF

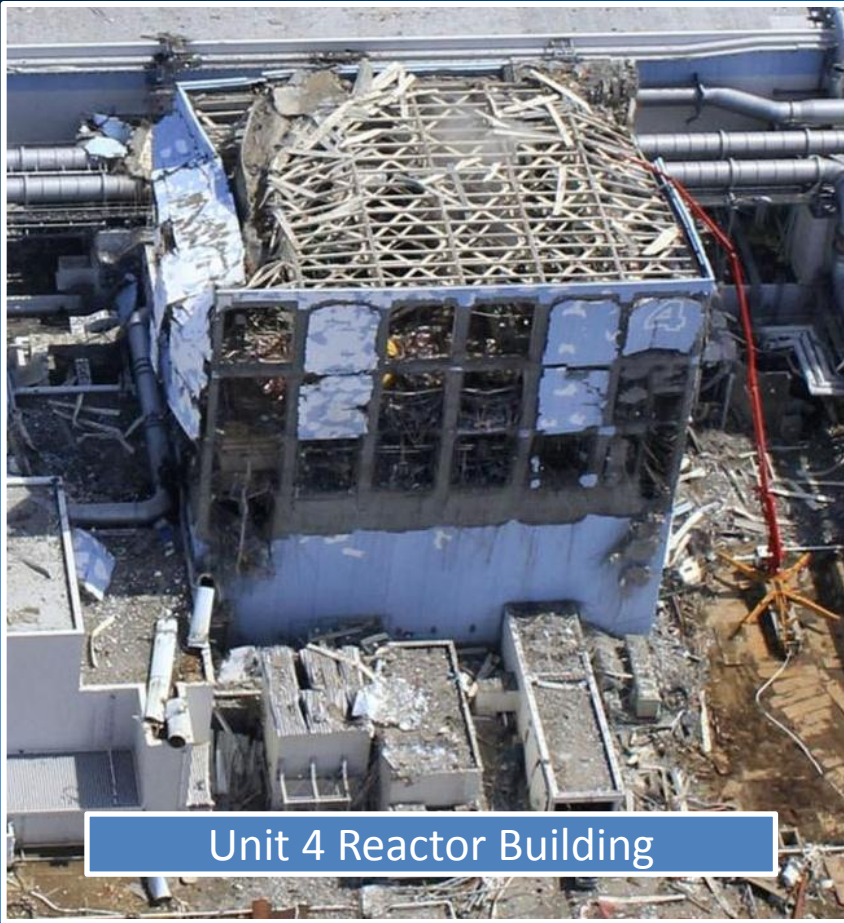
Unit 4

- 0614 (JST) on March 15, explosion in reactor building
- Extensive damage to reactor building (secondary containment)
- Site superintendent evacuates all non-essential personnel, leaving approximately 70 people on-site
- Caused by flow of gasses from Unit 3
